AC-TR-61-15

OPERATIONAL TEST AND EVALUATION  
NOISE SUPPRESSOR SYSTEM TYPE A/S32A-5

JUNE 1963

HEADQUARTERS  
TACTICAL AIR COMMAND  
United States Air Force  
Langley Air Force Base, Virginia

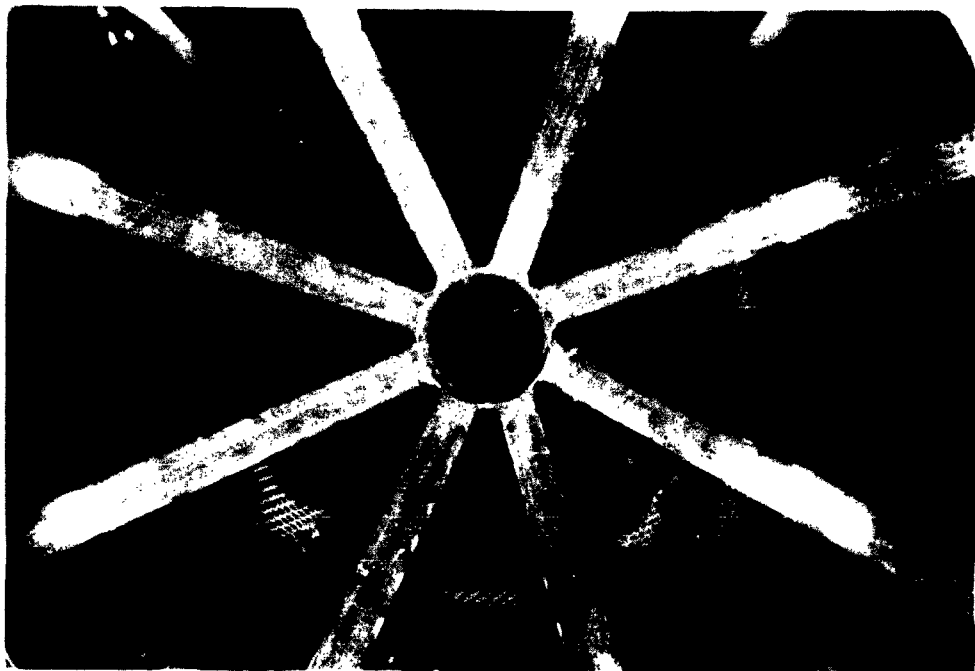
d. In May 1962, during an engine run of approximately one minute in the afterburner range, the suppressor diffuser screen began to burn and break off. It was found that approximately 3/4 of the diffuser had disintegrated. No further testing was accomplished until repairs were completed in September 1962. The repairs included replacement of the augments cone, diffuser, water sparger, augments spool and the hydraulic ram. 135 man-hours were required to install these items and accomplish other repairs necessary to return the suppressor to serviceable condition. During an engine run in November 1962, the diffuser screen started to breakup as soon as the engine was put into the afterburner range. It was found that the diffuser screen had almost entirely disintegrated. This was a relatively

new screen having only five hours of operating time. Examples of this type of damage are shown in Figures 5 and 6 in Annex A. Figure 7 in Annex A shows parts of the suppressor that were torn from it during an engine run.

FIGURE 5. Damaged diffuser screen

FIGURE 6. Damaged diffuser screen

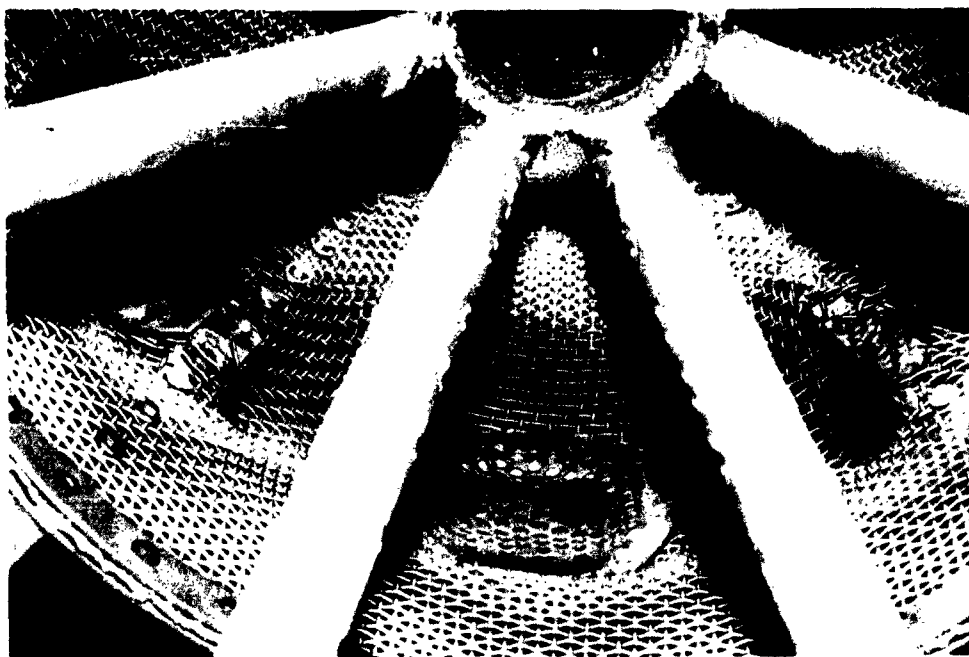
e. The wire mesh screen on the diffuser cone broke at the bottom during run #91. A bow had formed at this point early in the test and had continued to increase as operation continued. Close inspection revealed that eight "hot spots" had formed in the diffuser cone. These "hot spots" aligned perfectly with the cracked recessed areas in the water sparger inner ring between the sparger tubes. It was suspected that the hot exhaust gases generated during afterburner operation were being deflected radially and to the rear from these eight points at an angle of approximately 42 degrees into the diffuser cone wire mesh. The type damage and method of repair is shown in Figure 8 of Annex A.

FIGURE 8. Damaged diffuser screen showing method of repair

f. After run #56, several modifications approved by ASD were performed on the suppressor. These included the fabrication of a separate ring, 1/4 inch thick by 2 inches wide, to fit inside the water sparger inner ring. The damage to the diffuser cone was repaired by bolting a circular piece of 3/8 inch thick mild steel boiler plate over the damaged area.

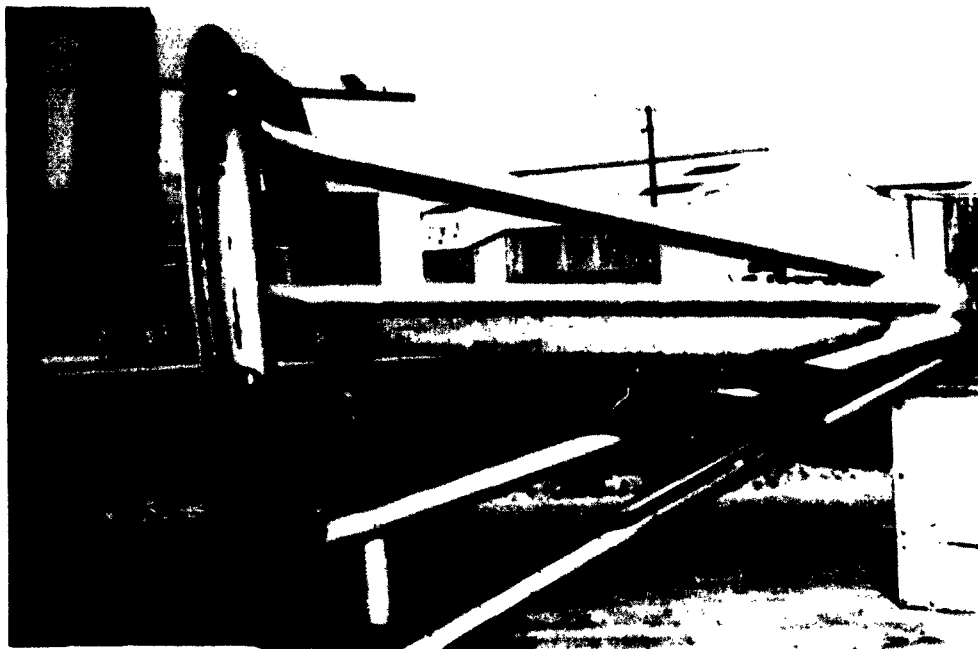
FIGURE 9. Water Sparger.

g. During test runs #70, #71, and #72, it was observed that the water flow through the sixteen water spray holes in the water sparger had decreased considerably. During run #72, the water flow ceased entirely, causing the ring to overheat. It was determined that the forward end of the ring had spread radially so that the pressure/velocity of the engine exhaust had overcome the water pressure. Thermal expansion and contraction had caused a small cup to form in the inner ring just forward of the water spray holes at the end of the water tubes. Eight additional 1/4 inch holes were drilled in each of the "cupped" areas to take advantage of the venturi effect just forward of each cup. The effect was excellent and caused the water to be drawn forward over the surface of the inner ring, back over the ring, cooling this area efficiently. After test run #96, another eight 1/4 inch holes were drilled along side the previously drilled holes. The original pair of holes in each of the eight water sparger tubes were plugged. There was no change in water pressure noted after these modifications. Figure 9 in Annex A shows the water sparger removed from the suppressor. The water spray holes drilled in the water sparger can be seen in Figure 10.
